Chiaki NAKAMURA  
Masaaki OZAKI

Japan Institute of Wastewater Engineering Technology

## ASEISMIC MEASURES AND DAMAGE OF WASTEWATER FACILITIES IN THE GREAT EAST JAPAN EARTHQUAKE AND TSUNAMI

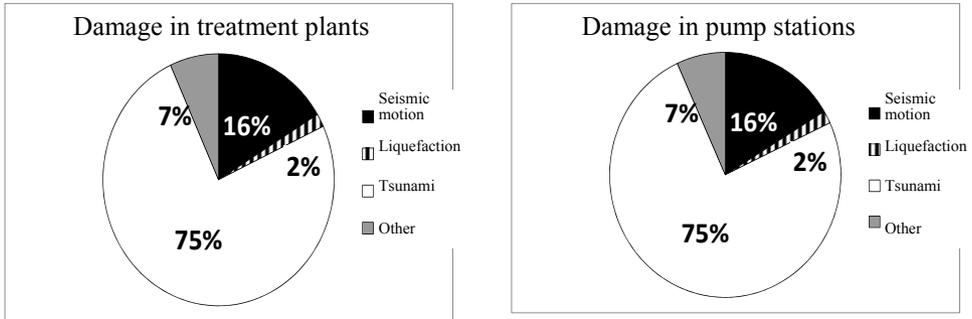
Figure-1 shows the results of damages in multiple facilities at disaster-stricken treatment plants and pump stations classified by damage type based on survey results. Damage by tsunami covers more than a half of the total at both treatment plants and pump stations.

Fig. 1. Breakdown of damage in facilities at treatment plants and pump stations (multiple answers)

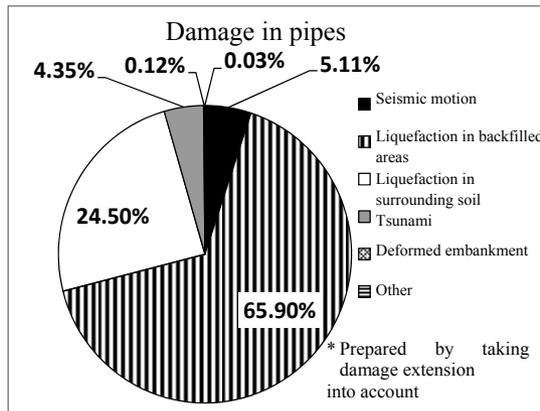
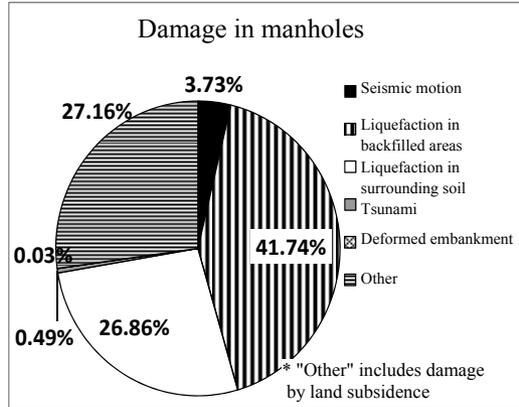
Among damages in pipes, liquefaction (in backfilled areas or surrounding soil) accounts for approximately 90% of the total, as shown in Figure-2. Such damage also covers approximately 70% of the total of damages in manholes.

Note that, however, damages in pipelines by tsunami were not clearly identified, since the situations in certain tsunami-hit areas had not been clearly investigated at the time of our survey.

Fig. 2 Breakdown of damages in pipelines (multiple answers)

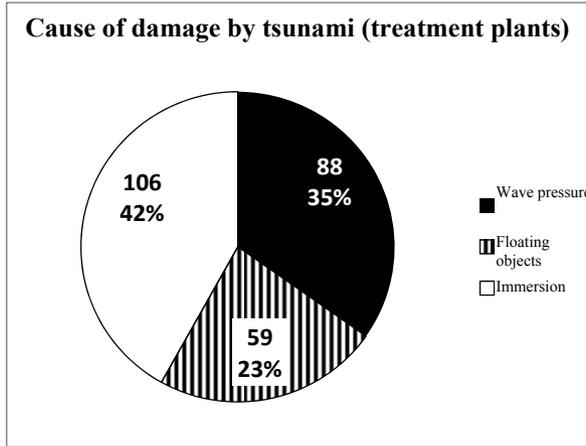
Based on the survey results, we sorted out the causes of damages in facilities at treatment plants. As shown in Figure-3, "damage by immersion" accounts for 42% of the total.

Fig.3 Breakdown of cause of damage by tsunami in facilities at treatment plants (multiple answers)

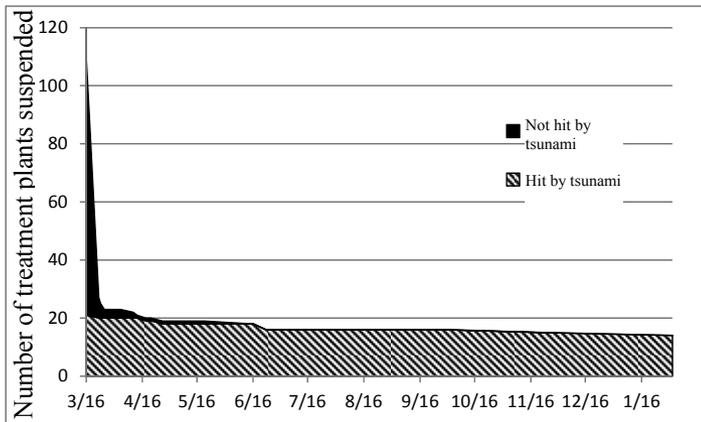
Figure 4 shows the number of treatment plants suspended, classified by whether or not hit by tsunami.

Focusing on the time to recover functions in treatment plants (operation suspension period), functions were recovered within one month at plants that had not been hit by tsunami, while it took more time for tsunami-hit plants to recover functions, though emergency repair were taken immediately.

Fig. 4. Comparison of the number of treatment plants suspended classified by whether or not hit by tsunami

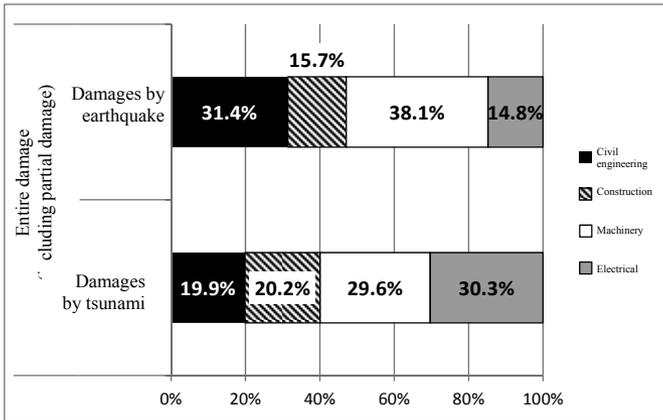
Figure-5 illustrates damages by tsunami, classified by type of works. The ratio of damage by tsunami tends to be higher than that by earthquake in electrical equipment.

Damages in electrical equipment by tsunami were mainly caused by immersion or lost of electrical rooms or control panels at sites.

Fig. 5 Comparison of damages classified by type of works between those by earthquake and tsunami

To prevent operation suspension for extended period of time by immersion resulted from tsunami at the largest level assumed, it is necessary to install or move electrical equipment at a higher floor, so as to provide waterproof measures for openings such as windows or doors of buildings for immersion prevention, as well as for the entire equipment.

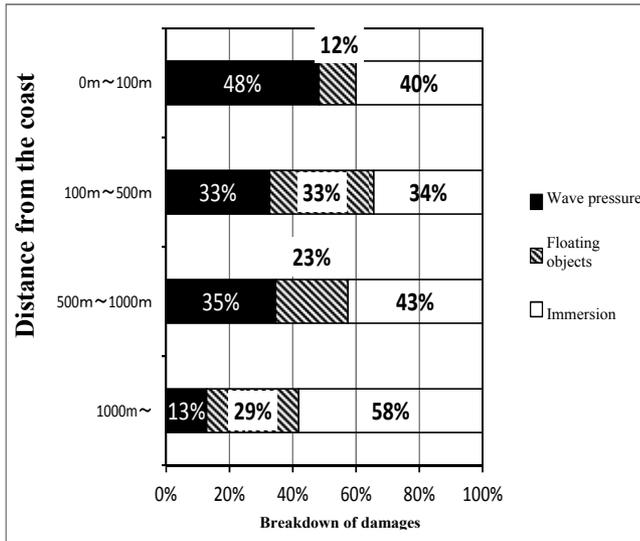
The relationship between the distance of the treatment plant sites from the coast and causes of damage in facilities in treatment plants (wave pressure, immersion, floating objects) are presented in Figure-6. From these results, it becomes clear that damage by wave pressure increases as the distance is shorter, while that by immersion or floating objects tends to increase as the distance is longer.

Fig. 6 Relationship between the distance from the coast and causes of damage (multiple answers)

At treatment plants near the coast, it is necessary to efficiently implement hardware measures considering immersion paths of floating objects, identify structures susceptible to have wave power even at the time of rarely occurring tsunamis, as well as their locations. It is desirable to vigorously introduce tsunami simulation<sup>3)</sup> (Figure-10) by analysis, as it can be used for a quantitative verification method for assuming damage by tsunami and effects of measures.

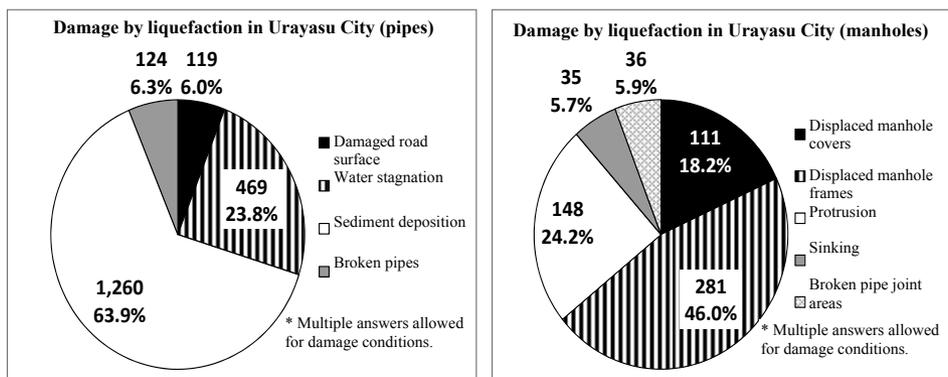
Among damages by liquefaction in surrounding soil, causes of damages in pipelines in Urayasu City, Chiba Prefecture are presented in Figure-7, since damages at this city were especially devastating. Among damages in pipes, those caused by sediment deposition accounts for 63.9%, almost two-thirds of the total; pipes were clogged with a large amount of sediment inflow, resulting in a suspension of pipe flow for a long period. Among damages in manholes, those caused by displaced manhole frames account for 46.0%.

Fig. 7 Cause of damage in pipelines by liquefaction in Urayasu City (Multiple answers)

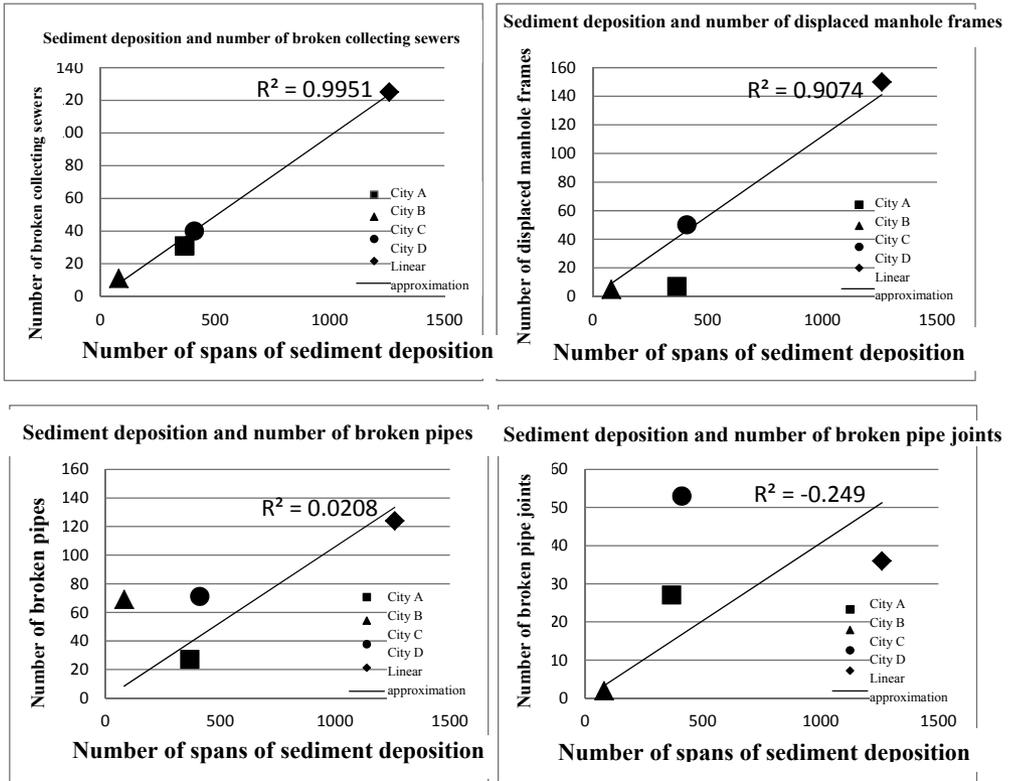
To understand the path of sediment inflow at the places damaged by sediment deposition, we checked the number of places where sediment deposited, broken collecting sewers, displaced manhole frames, broken pipes, broken pipe joints, as well as their positions, confirmed by TV cameras placed at four cities hit by liquefaction in surrounding soil. Figure-8 shows these results and their relationships.

Based on the sorted results, we confirmed the comparatively-higher linear approximation relationship between sediment deposition and broken collecting sewers/displaced manhole frames.

Fig. 8 Relationship between number of sediment deposition and that of each damage

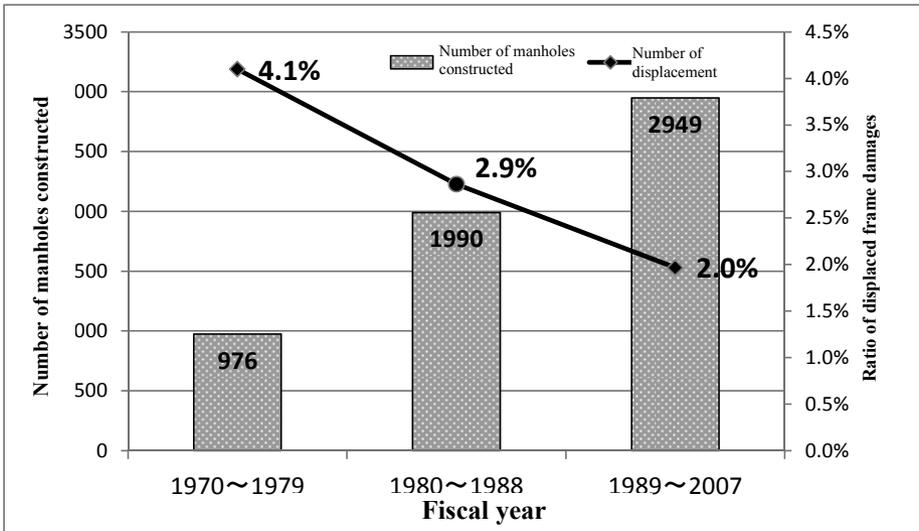
Urayasu City started construction of sewerage systems in 1970, when manholes having less unevenness at the assembly section were used, which leads to easy displacement between blocks. Figure-9 describes the relationship between the number of manholes constructed by various periods of time and the number of displaced manhole frames to calculate the damage ratio. Based on the results, it reveals that the high ratio of displaced manhole frames which were constructed in an earlier period.

Fig. 9 Relationship between the number of manholes constructed classified by periods of time and displaced frame damages

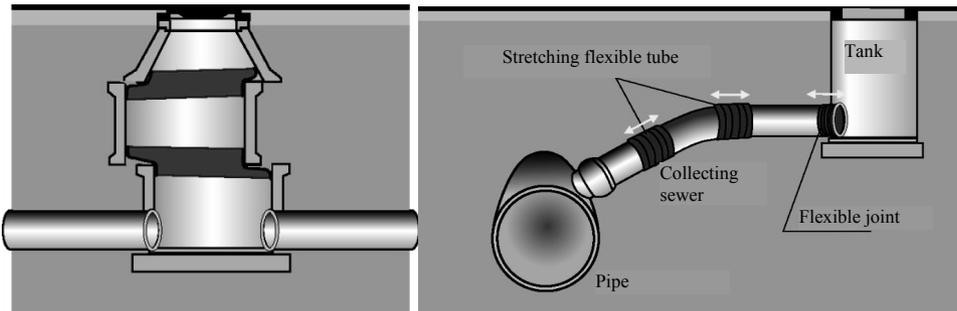
Fig. 11 Concept diagram of measures to prevent sedimentation inflow into pipelines

To prevent inhibition of falling functions due to sedimentation inflow into pipelines, measures of securing flexibility and elasticity in joint areas at assemblies for old manholes, and in joints for collecting sewers are required for assumed sedimentation inflow areas. Figure-11 illustrates the concept of measures to prevent sedimentation inflow into pipelines.
